Re:    Compliance Evaluation Inspection  
      Bartlett Sewage Treatment Plant (STP) #1  
      NPDES Permit No. TN0066800  
      Shelby County  
      Bartlett STP Biosolids Operation and Management  
      State Operation Permit For Land Application of Biosolids No. TNB066800  
      Tipton County

## ICIS NPDES Facilities Inspection Report

**Compliance Inspection for Individual NPDES Permit**

<b>Facility Name:</b> Bartlett STP #1	<b>NPDES Tracking Number:</b> TN0066800
<b>Permit Effective Date:</b> November 1, 2013	<b>Permit Expiration Date:</b> September 30, 2017
<b>Date and Time of Inspection:</b> 4/7/2015	<b>Inspector Name:</b> Eddy Bouzeid

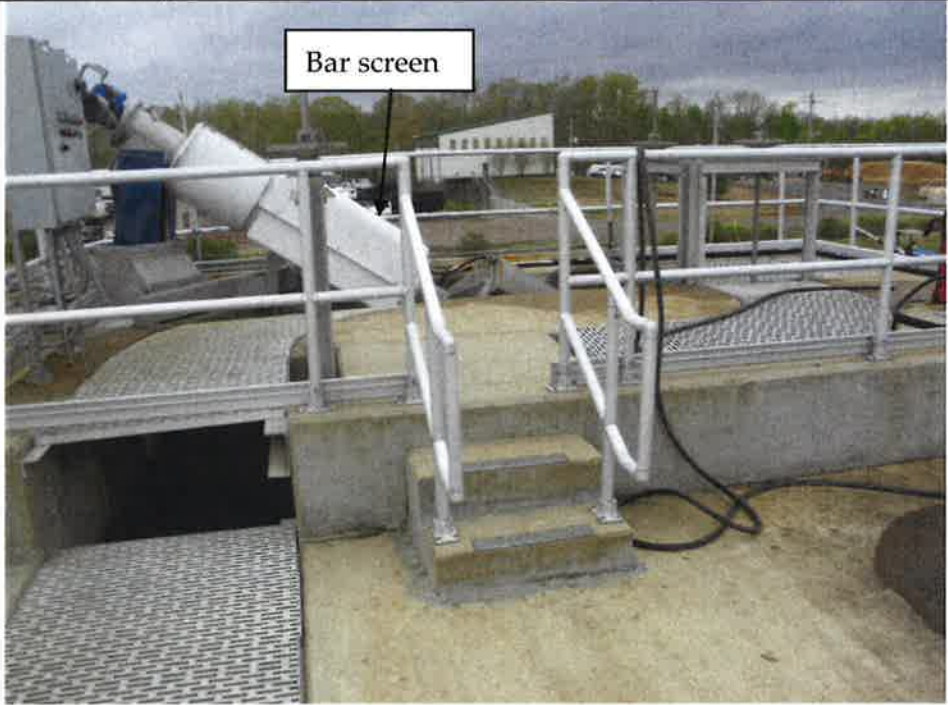
<b>Client or Facility Name:</b> Bartlett STP #1		<b>Site Location:</b> Bartlett, Shelby County	<b>Tracking No.:</b> TN0066800
<b>Photo No.</b> 1	<b>Date</b> 4-7-2015

The Bartlett STP consists of two main lift stations at the head of the plant, followed by a headwork building that houses the bar screen (photo 1). From the headwork, the wastewater is pumped to two oxidation ditches for intensive aeration (photo 2). From the oxidation ditches the treated wastewater is clarified via two secondary clarifiers (photo 3), then disinfected using ultraviolet (UV) lights (photo 4) before being discharged.

<b>Description</b> View of bar screen at headwork

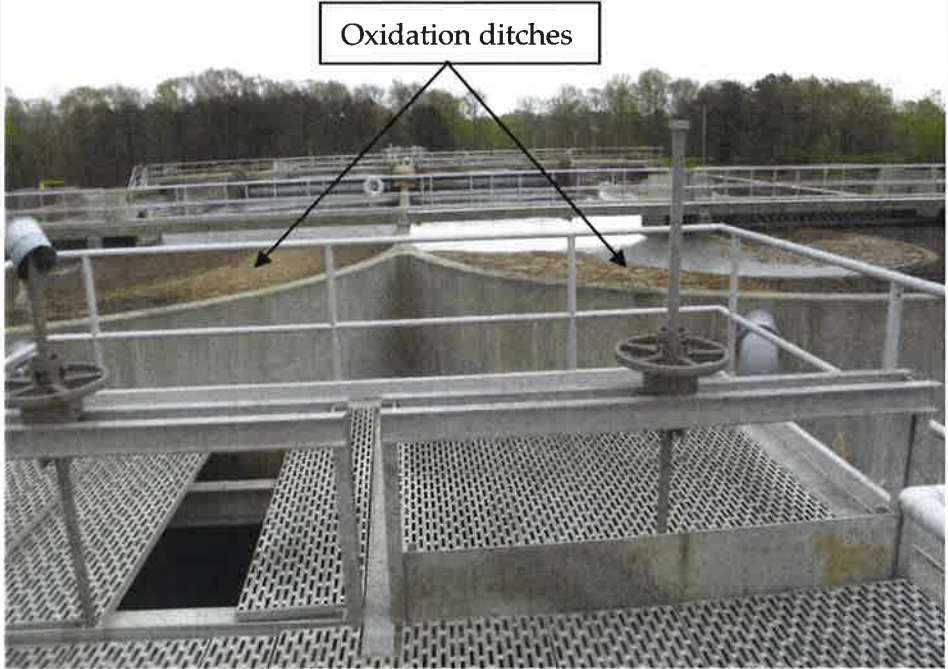
<b>Photo No.</b> 2	<b>Date</b> 4-7-2015

<b>Description</b> View of oxidation ditches

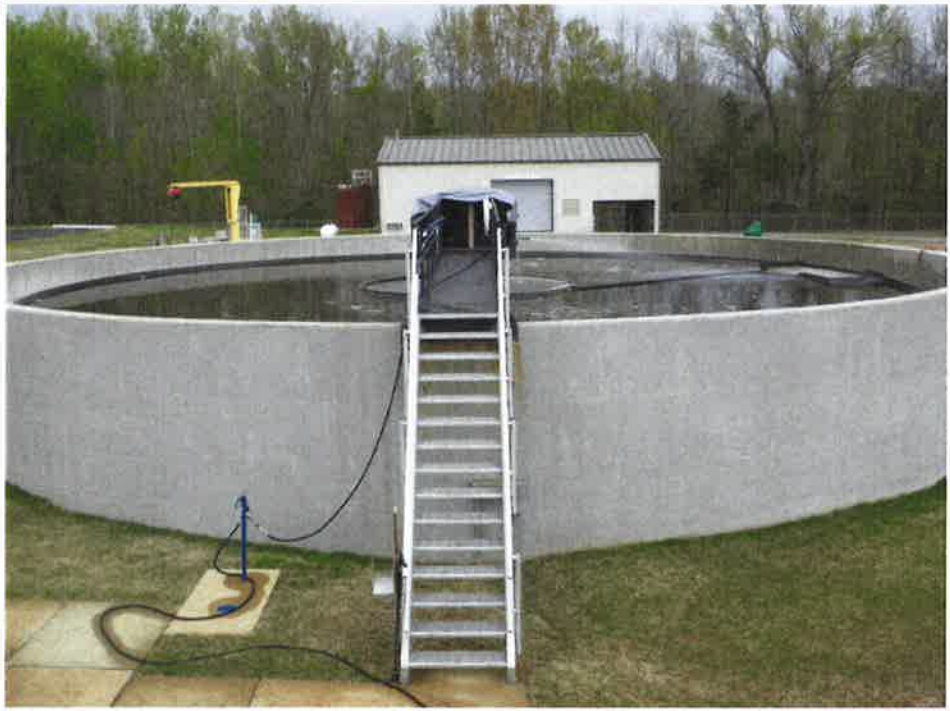
<b>Client or Facility Name:</b> Bartlett STP #1		<b>Site Location:</b> Bartlett, Shelby County	<b>Tracking No.:</b> TN0066800
<b>Photo No.</b> <div style="text-align: center;">3</div>	<b>Date</b> <div style="text-align: center;">4-7-2015</div>

<b>Description</b> View of one of the secondary clarifiers			
<b>Photo No.</b> <div style="text-align: center;">4</div>	<b>Date</b> <div style="text-align: center;">4-7-2015</div>

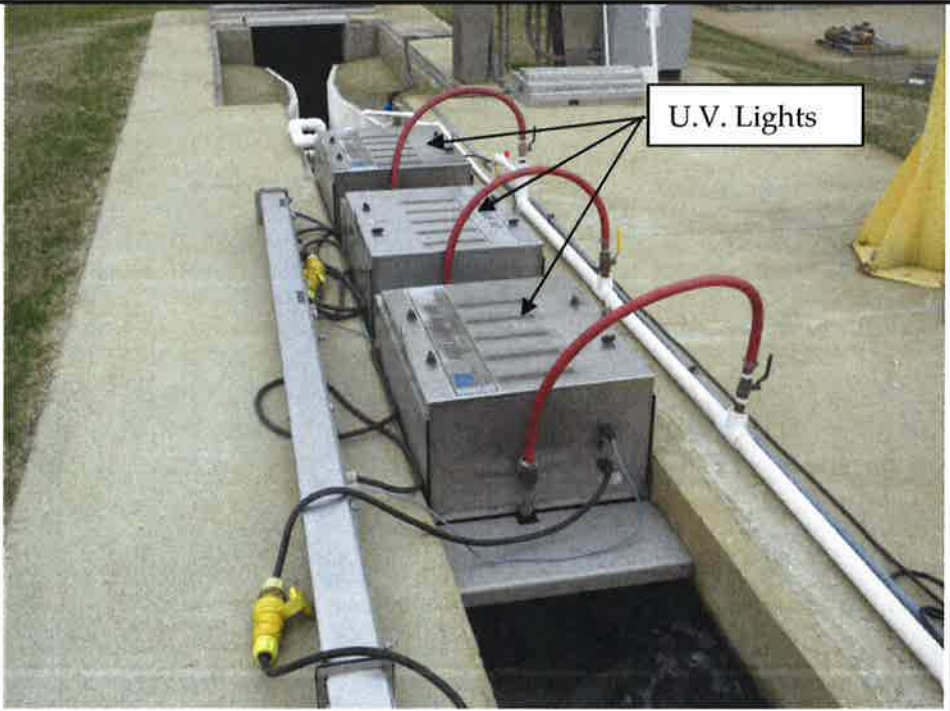
<b>Description</b> View of the Ultraviolet lights

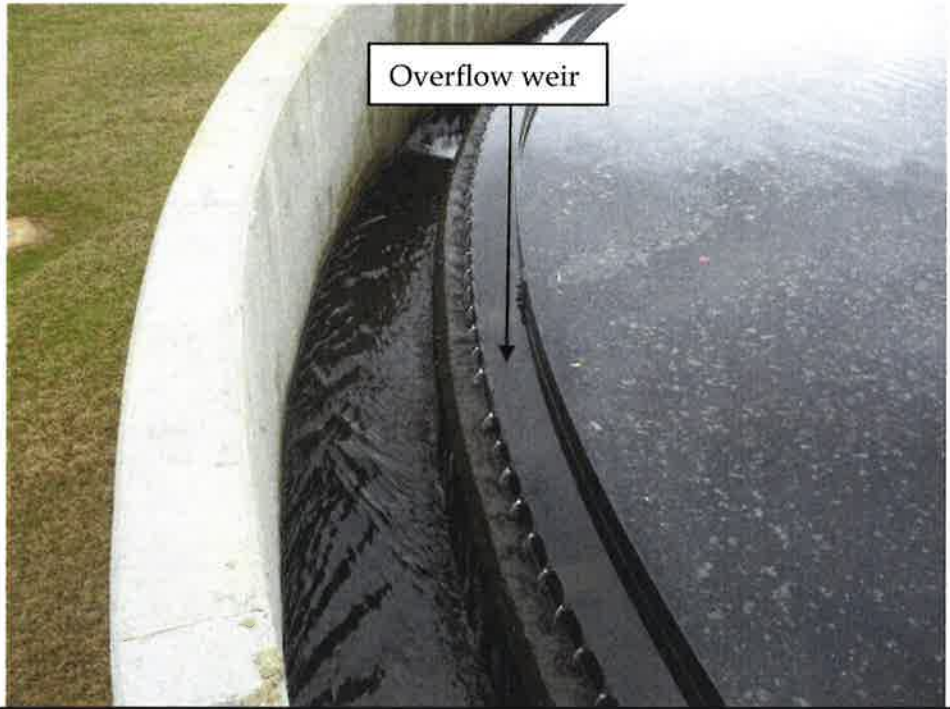
The overflow weirs from the clarifiers were clean at the time of the inspection (photo 5). According to Mr. Gamblin, the weirs are cleaned once a week to prevent algae and solids accumulation.

<b>Description</b> Close-up view of the clarifier (from photo 3) overflow weir			
<b>Photo No.</b> <div style="text-align: center; border: 1px solid black; width: 40px; margin: 0 auto;">6</div>	<b>Date</b> <div style="text-align: center; border: 1px solid black; width: 100px; margin: 0 auto;">4-7-2015</div>

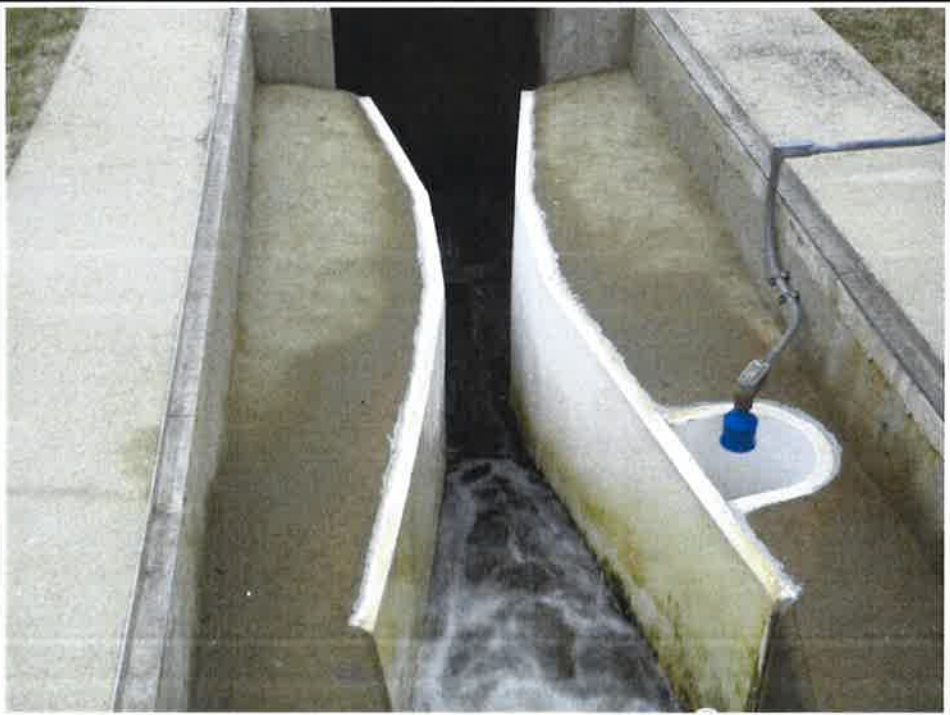
The effluent from the STP's concrete structure was clear (photo 6). The odor at the time of the inspection was minimal.

<b>Description</b> View of effluent from the STP concrete structure. The effluent sample is taken from the flume prior to discharging to the Loosahatchie River.

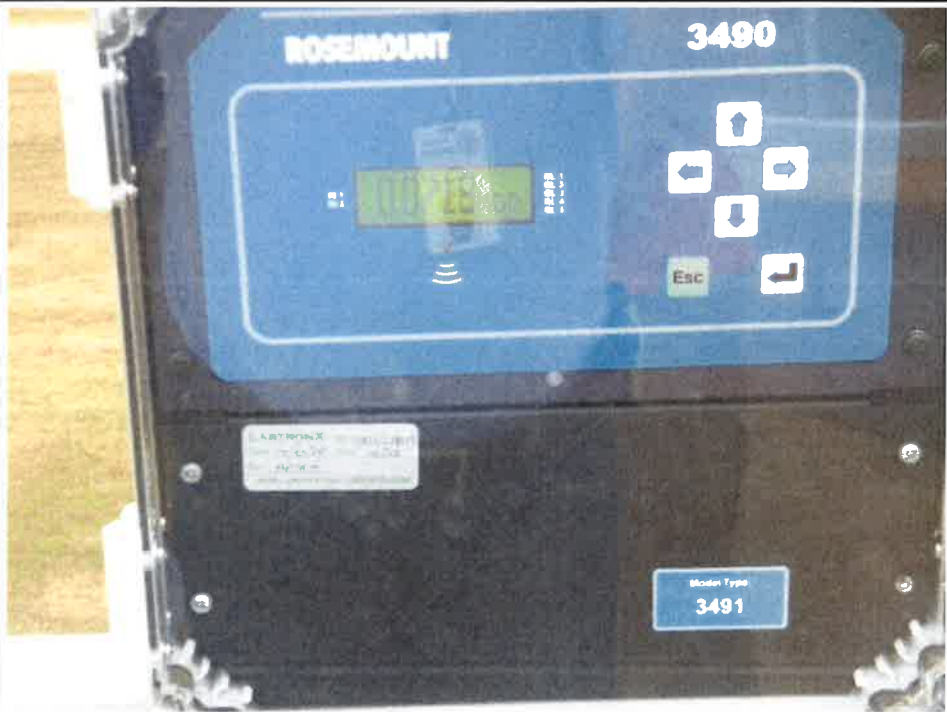
<b>Photo No.</b> 8	<b>Date</b> 4-7-2015

The plant has two digital flow measurement devices for the influent and effluent. The devices were functioning at the time of the inspection (photos 8 and 9). The devices are calibrated annually by LabTronX from Nashville, an independent contractor. The certificates for the calibrations by LabTronX were available at the plant's laboratory. The devices were last calibrated on October 29, 2014.

<b>Description</b> View of the influent digital flow device. At the time of the inspection, this device was functioning properly.

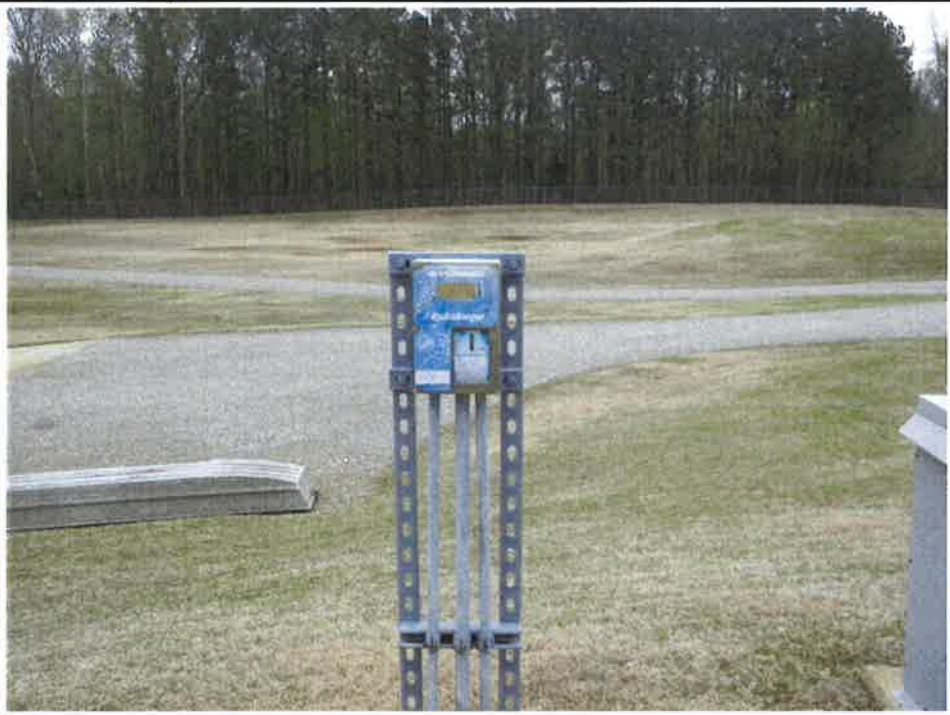
9	4-7-2015		
<b>Description</b> View of the effluent digital flow device. At the time of the inspection, this device was functioning properly.

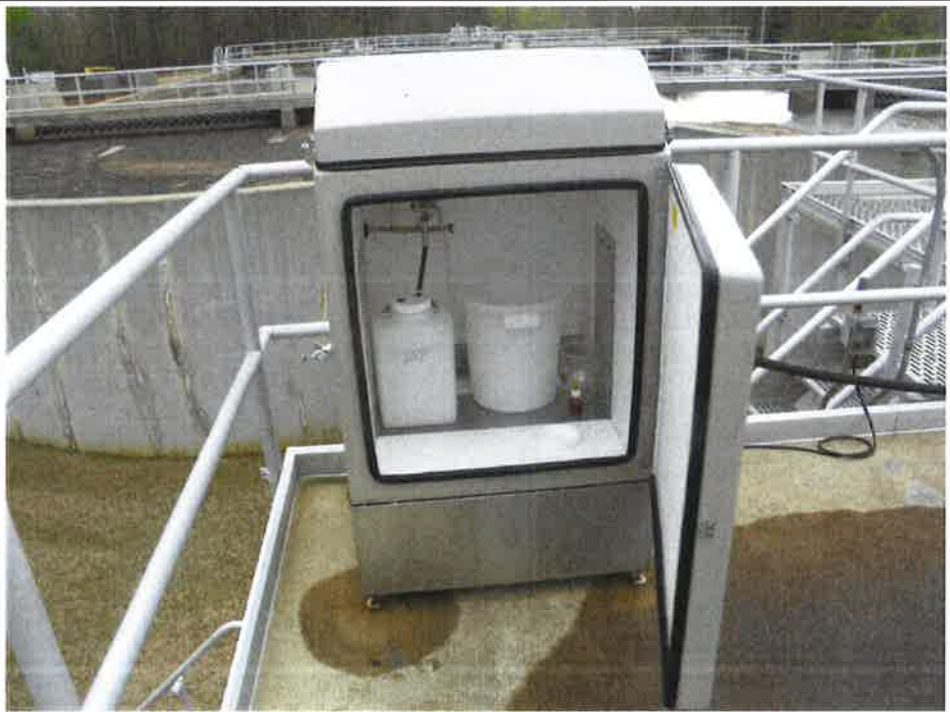
The Bartlett STP has automatic flow proportional samplers for the influent and effluent as required by the permit (photos 10 and 11). The automatic samplers are capable of providing adequate refrigeration during the sampling period. Each sampler is equipped with a control bottle and a thermometer. The readings on the thermometers in the samplers were 4 degrees Celsius at the time of the inspection, which is below the 6 degrees Celsius required by the permit.

10	4-7-2015	
<b>Description</b> View of the influent composite sampler. At the time of the inspection, it appears that this device was properly maintained.

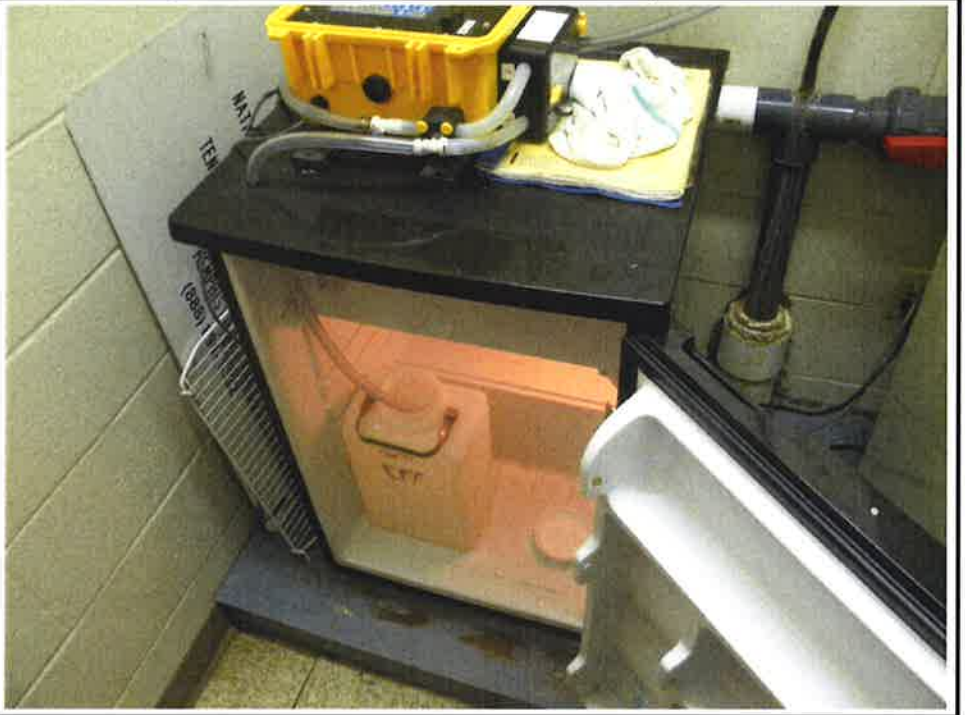
<b>Client or Facility Name:</b> Bartlett STP #1		<b>Site Location:</b> Bartlett, Shelby County	<b>Tracking No.:</b> TN0066800
<b>Photo No.</b> 11	<b>Date</b> 4-7-2015

<b>Description</b> View of the effluent composite sampler. At the time of the inspection, it appears that this device was properly maintained.
